Concrete Materials Testing of  
**Kauffman Stadium**  
Kansas City, MO

Prepared For:  
Kansas City Royals Baseball Corporation and  
Jackson County Sports Complex Authority and  
One Royals Way  
Kansas City, MO 64129

December 19, 2007

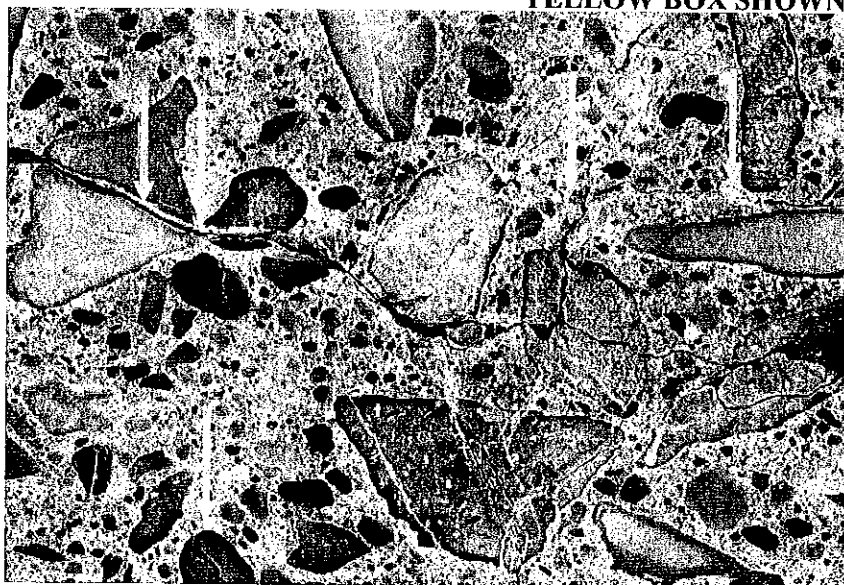
**PLATE 17**  
**PREPARED SURFACE SHOWING CRACKING/MICROCRACKING**  
**SOME ALKALIC GEL DEPOSITS S SHOWN BY YELLOW ARROWS**  
**NOTE: MANY VOIDS INFILLED WITH ALKLAIC GELS AND/OR ETTRINGITE**

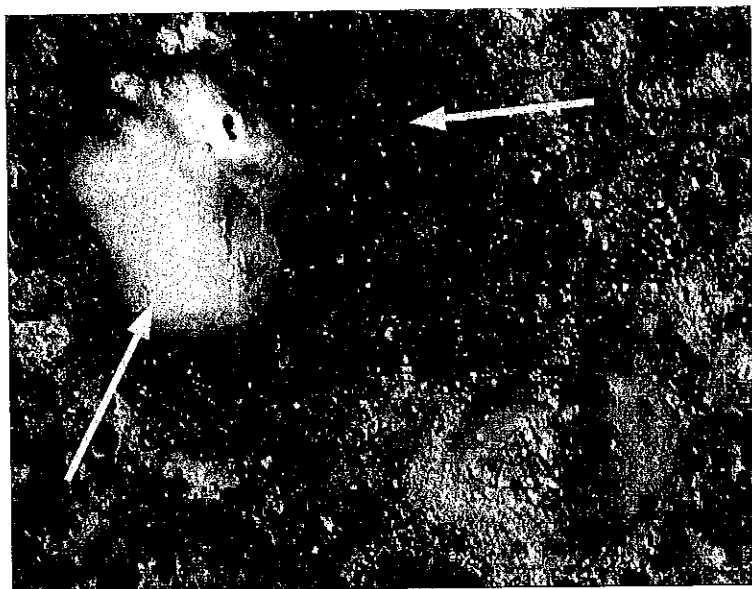
**PLATE 9  
CUT SURFACE SHOWING ALKALIC GEL EXUDATIONS ON  
AGGREGATE PARTICLE (YELLOW ARROW) AND  
IN ADJACENT VOID, CLEAR-WHITE CRACKED ALKALIC  
GEL LINING (RED ARROW)**

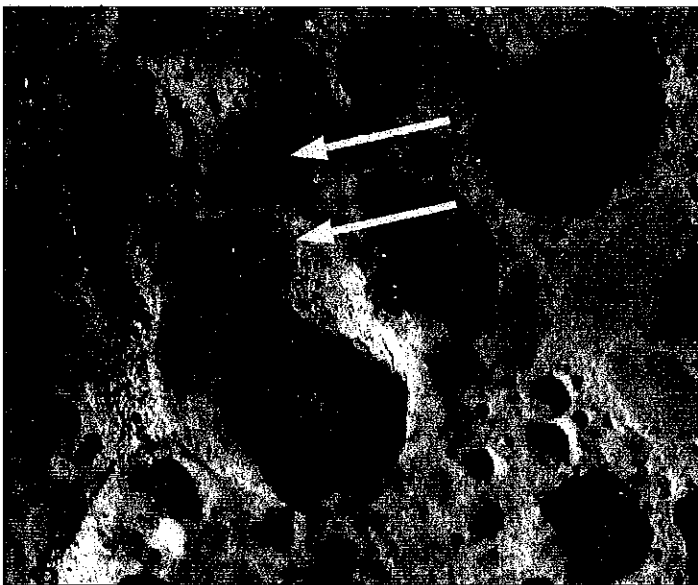
**PLATE 27  
PREPARED SURFACE SHOWING CLEAR,  
CRACKED GEL EXUDATIONS IN VOIDS  
(YELLOW ARROWS)**

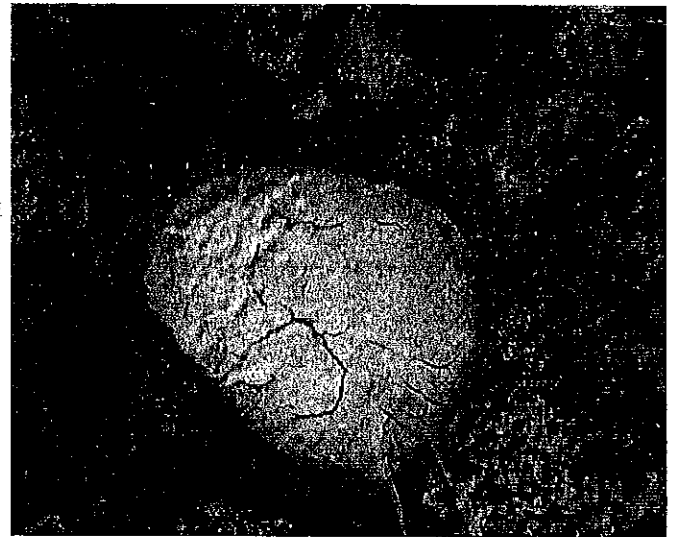
**PLATE 10**  
**CUT SURFACE SHOWING GEL EXUDATION**  
**AFTER WATER IMMERSION OF SAMPLE**  
**TRIMMING**

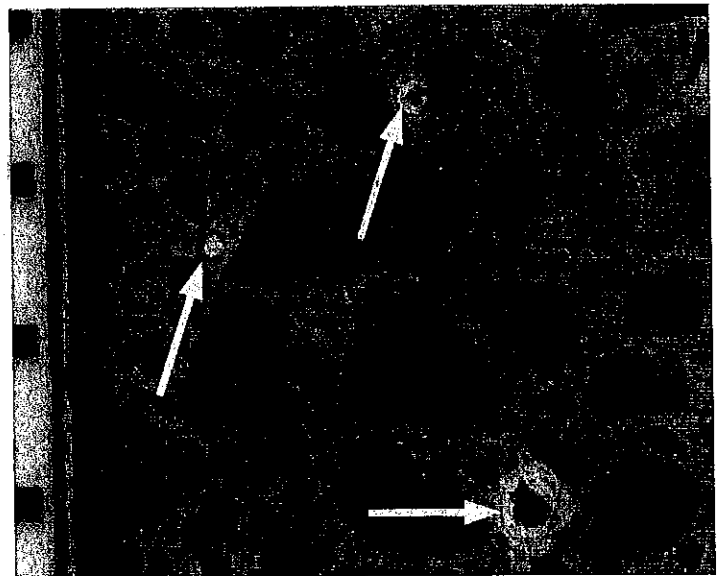
**PLATE 20  
PREPARED SURFACE SHOWING SECONDARY,  
INTERNAL DEPOSITS OF ALKALIC GEL  
AND/OR ETTRINGITE IN VOIDS AS COATINGS  
AND AN INFILLING (YELLOW ARROWS)**

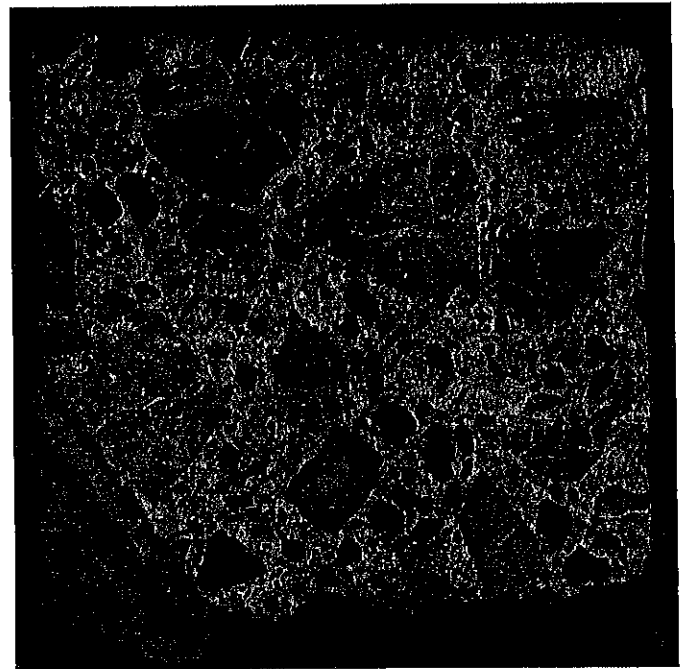
**PLATE 6**  
**PREPARED SURFACE /UPPER PORTION**  
**SHOWING HEAVY FRACTURING IN**  
**PASTE AND AGGREGATES**
