Concrete Materials Testing of  
**Kauffman Stadium**  
Kansas City, MO

Prepared For:  
Kansas City Royals Baseball Corporation and  
Jackson County Sports Complex Authority and  
One Royals Way  
Kansas City, MO 64129

December 19, 2007

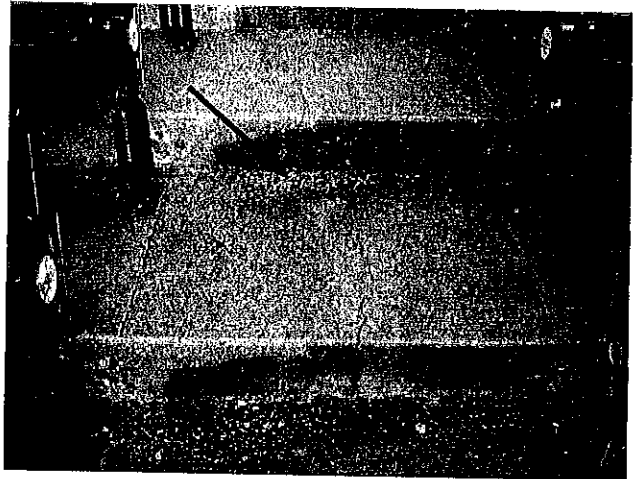
1. Freeze-thaw scaling distress is prevalent along the aisles in the Field seating bowl.

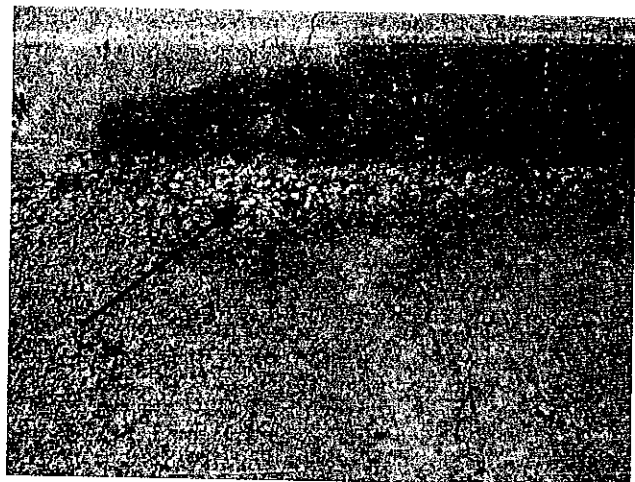
2. Close-up of severe scaling showing complete loss of cement paste and exposed coarse aggregate. Repair of this condition will require partial-depth repair, because water ponds in this location accelerating the deterioration.

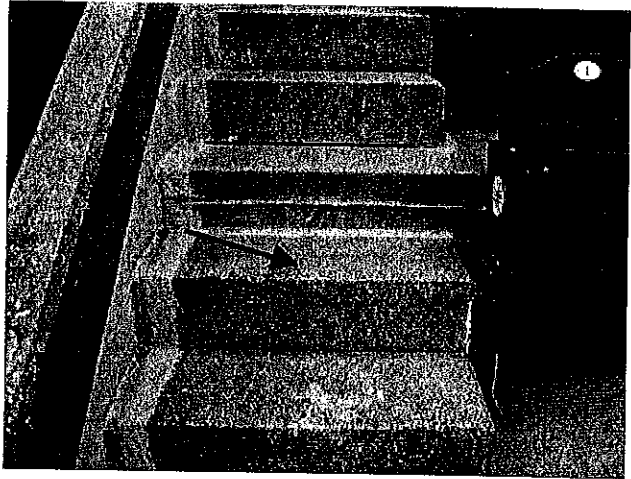
3. Moderate to advance scaling distress on precast stair blocks

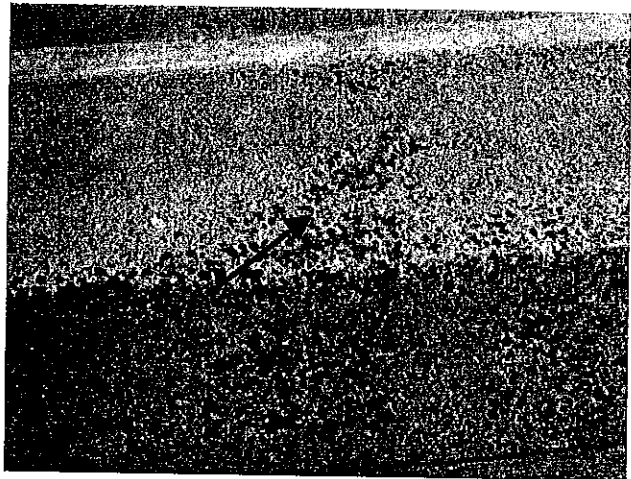
4. Close-up of scaling distress on precast step in the View Seating Bowl. This stair is still functional so replacement at this time is not necessary. However, scaling will continue to degrade the step so future replacement is expected.

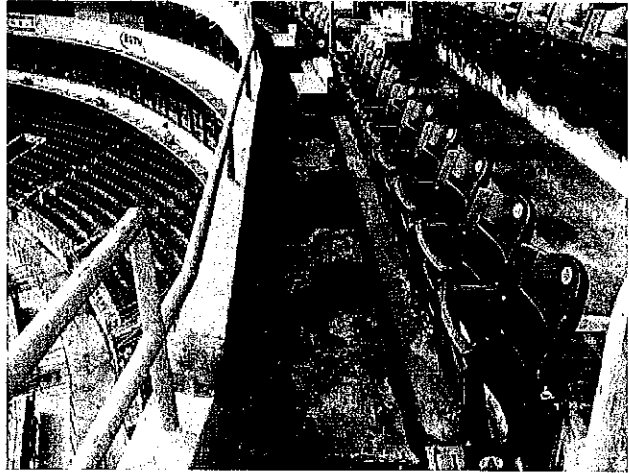
6. Failed coating along row A of View Seating Bowl. The failed coating covers a delaminated topping mortar and structural slab under the seats. The topping was used to create a trough under the seats. The sealant along the edge of the trough has deteriorated and allows water under the topping and coating, which contributes to premature coating failure.

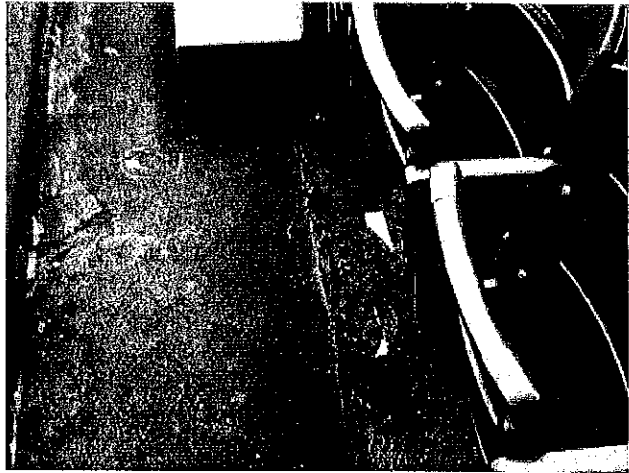
7. Poor drainage allows water to pond in the trough and seep under the mortar and coating.

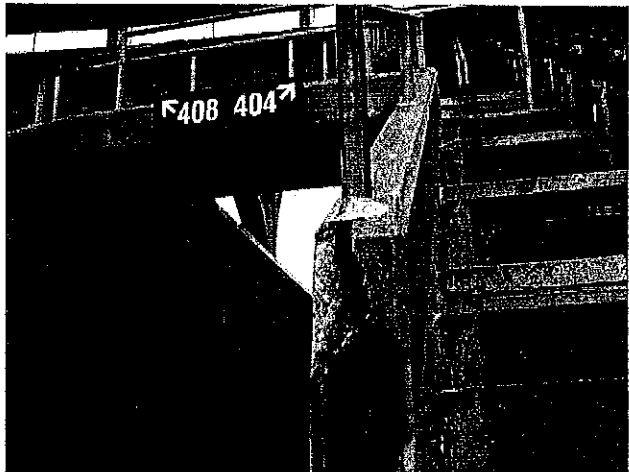
8. Corrosion induced distress from handrail posts embedded into the portal walls is common.

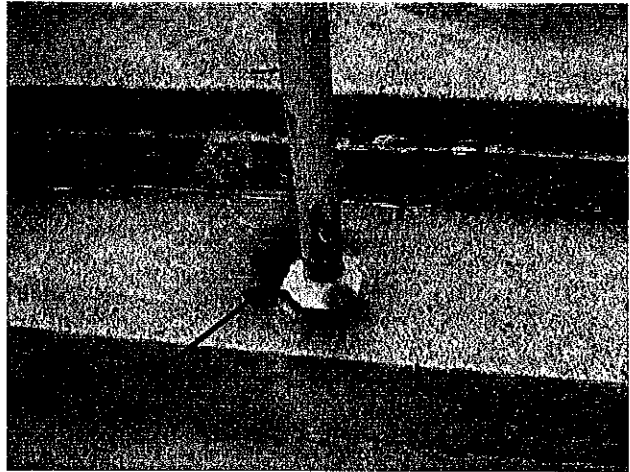
9. Replacement of handrails with excessive corrosion is required.

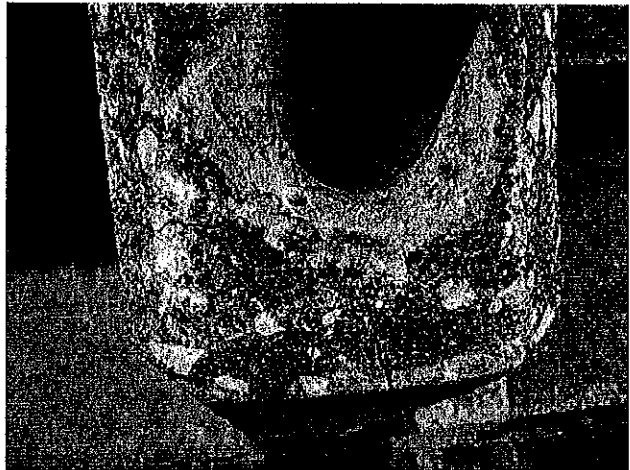
10. Cracking from pipe corrosion inside the concrete. This handrail and concrete should be repaired. (Typical condition)

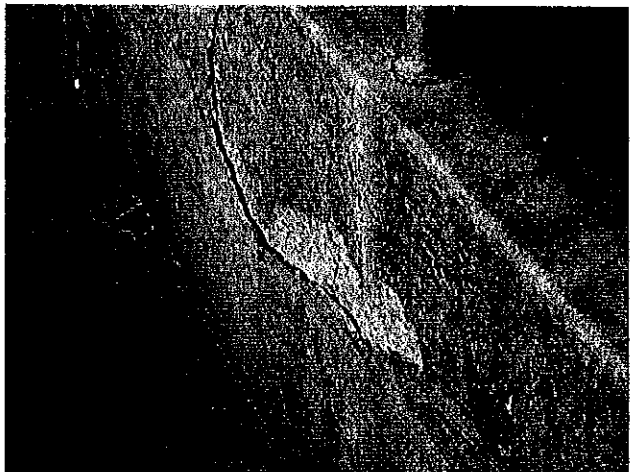
11. Failure of previous "cosmetic" surface patch with cracking distress at handrails.

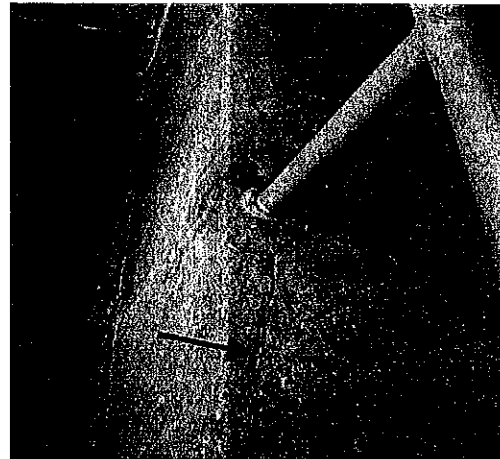
12. Handrail corrosion-related cracking along the wall between the Field Level and Plaza Level seating areas. Partial-depth wall repair behind reinforcing and handrail pocket is required at several locations.

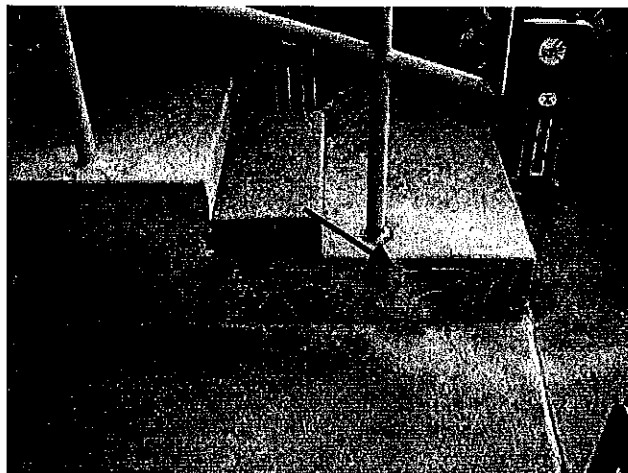
14. ASR cracking distress in slab on grade at Section 139 railing. This slab and stair should be replaced.

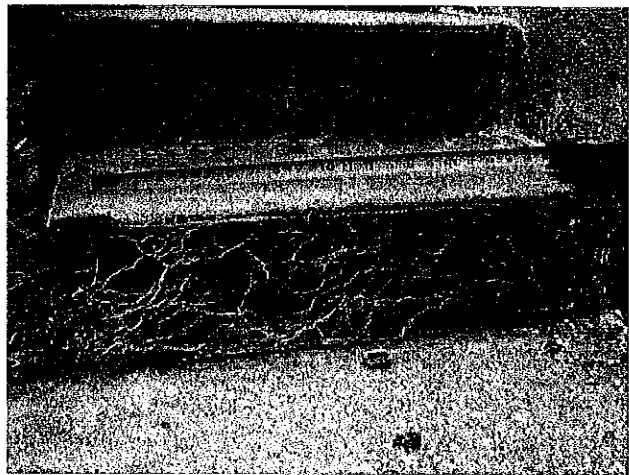
15. Severe ASR distress of stair at Section 343. Note tightly spaced cracks with exudation. Removal and replacement of concrete in this condition is recommended at this time. When repairing ASR distressed concrete, topical application of 30% lithium nitrate solution to the interface between existing and replaced concrete is recommended.

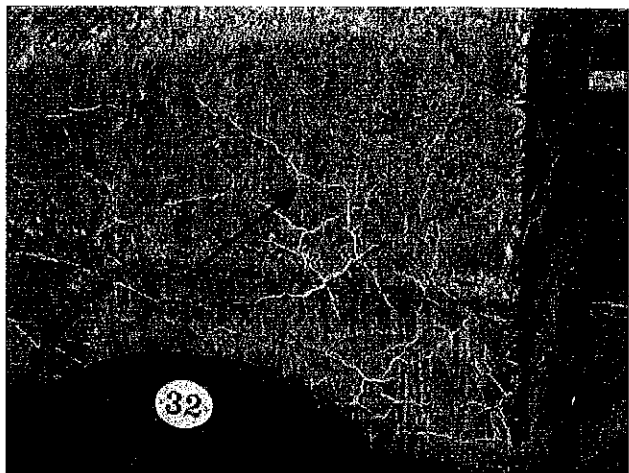
16. Advanced ASR distress of wall adjacent to stair at Section 343. Removal and replacement is recommended.

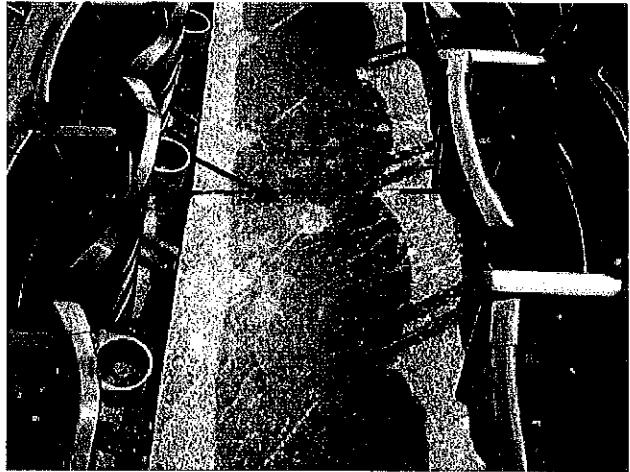
18. Advanced ASR distress along construction joint in Field Level seating Section 130 slab on grade. Note cracking pattern with ASR gel exudation and core 130P2 location. Concrete in this condition will probably need to be replaced in 5 to 10 years.

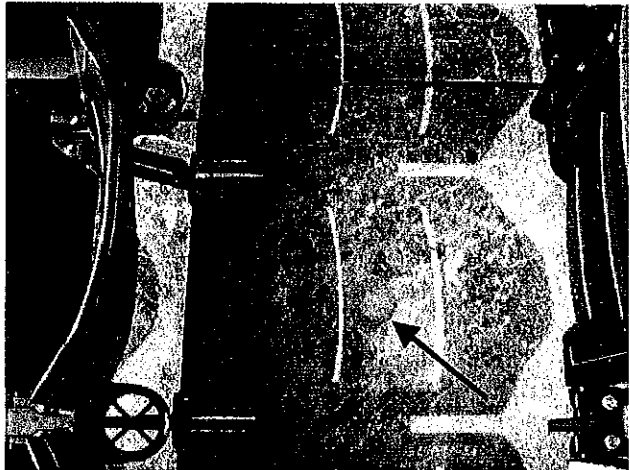
19. Advanced ASR distress along construction joint in field level seating Section 127 slab on grade. Note cracking pattern with exudation and core 127P1 location away from expansion joint.

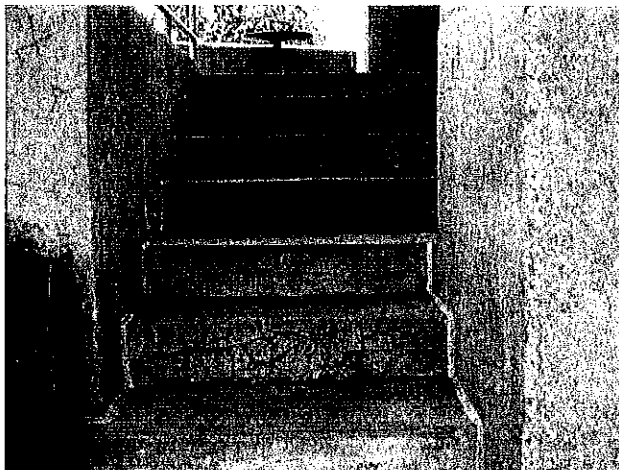
21. Advanced ASR of stairs from Club Concourse to right field Section 238. It is likely that the stairs will need replacement within 5 to 10 years.

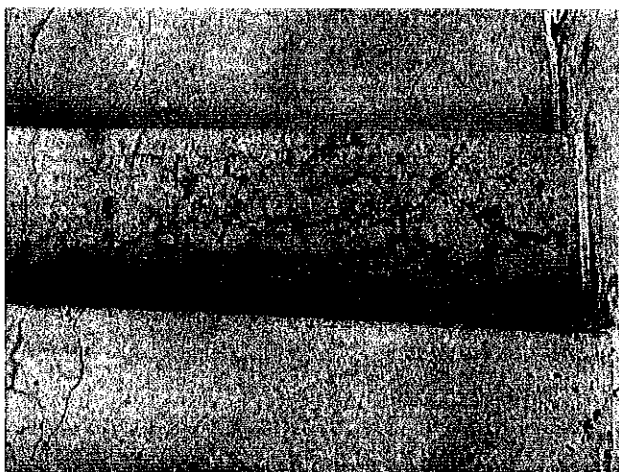
22. Close-up of Section 238 step that was cored for petrographic examination. Note close spacing of interconnected cracks. Concrete in this condition is probably too far gone to treat effectively.

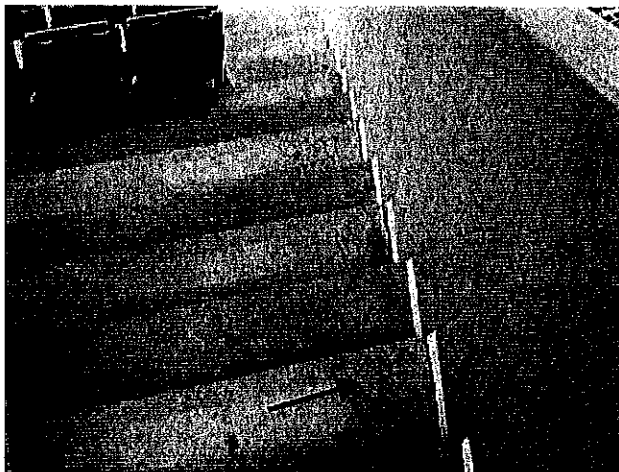
23. Stairs along the wall in Section 238 Club Level right field. Note Moderate ASR cracking distress adjacent to failed sealant.

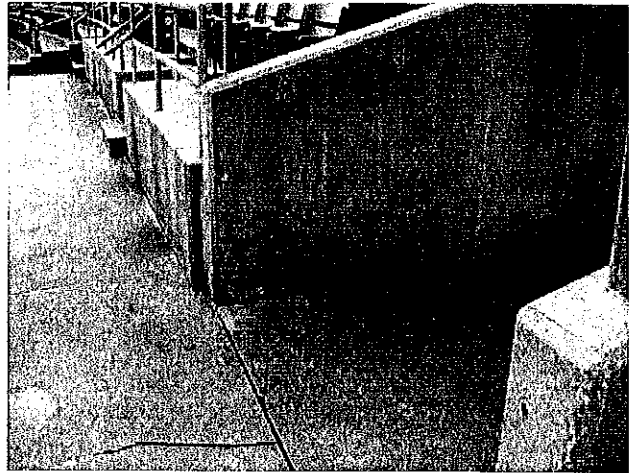
24. Moderate ASR distress of portal wall in right field. Note cracking pattern at base of the wall where the exposure to moisture is greatest. This wall is a candidate for lithium nitrate treatment, as replacement within the next 20 years is likely.

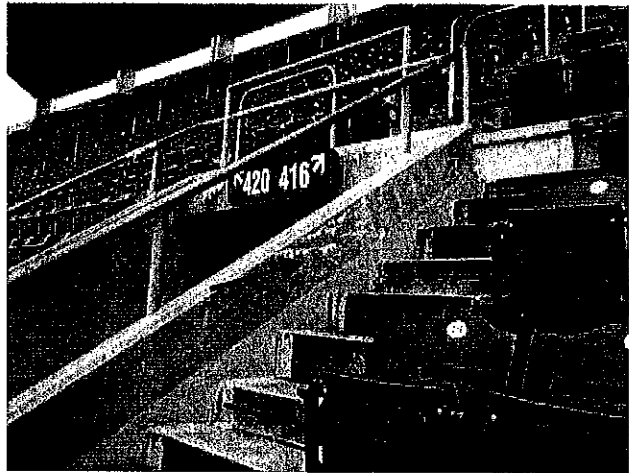
25. Advanced ASR Cracking with exudation along Portal wall on View Level. Cores for petrographic examination were taken from this location. Replacement of this concrete will be necessary within 5 years.

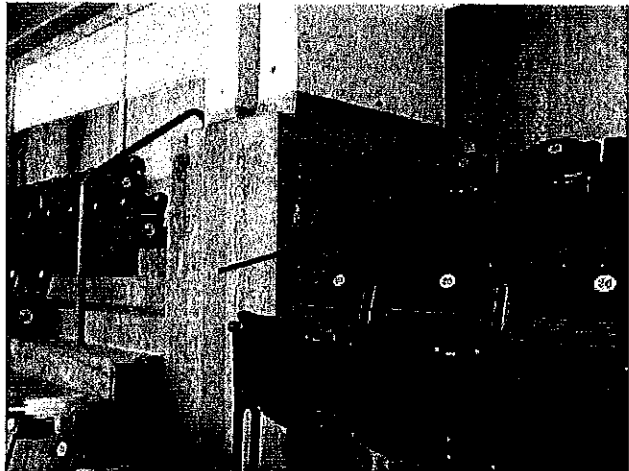
26. Severe ASR distress of the expansion joint pedestals supporting the View Roof at Section 423. Cores were taken from this pedestal for petrographic examination and compressive strength. Core strength was approximately 6000 psi.

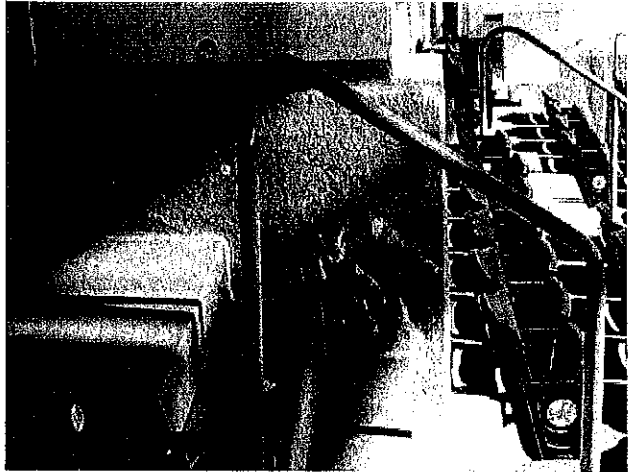
27. Advanced ASR distress of left field pedestal. Note exudation and cracking below the top 12 inches of the pedestal. This indicates that the concrete below the steel tube is of questionable quality.

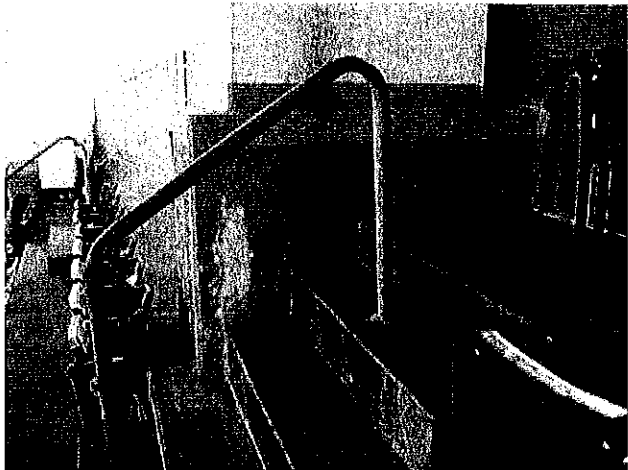
28. Advanced ASR distress of View Roof pedestal in Section 428. Note exudation and cracking below the top 12 inches of the pedestal. This indicates that the concrete below the steel tube is of questionable quality.

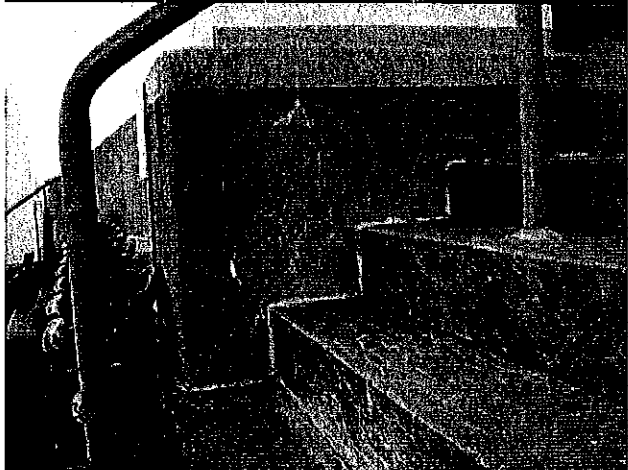
29. Advanced ASR distress of View Roof pedestal and stair in Section 432.

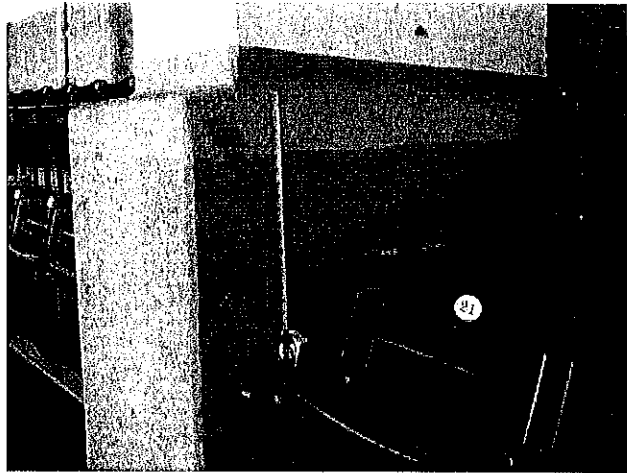
33. Minimal ASR distress observed at pedestal from Section 400 that was sampled. Core compressive strength exceeded 10,000 psi, and petrographic examination identified internal ASR distress. Future replacement is expected in approximately 10+ years.

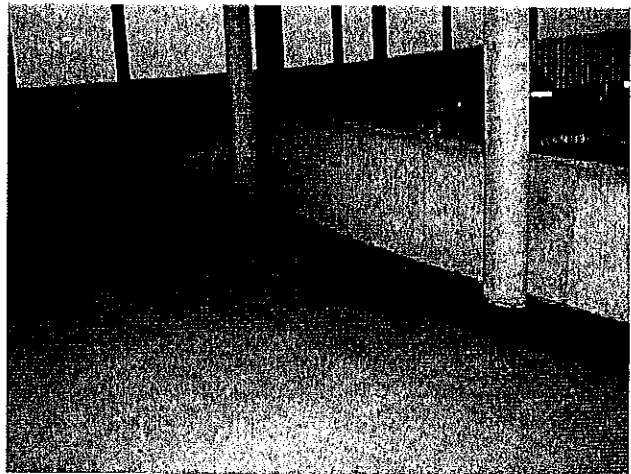
37. Typical drainage pattern of the Pedestrian Ramps.

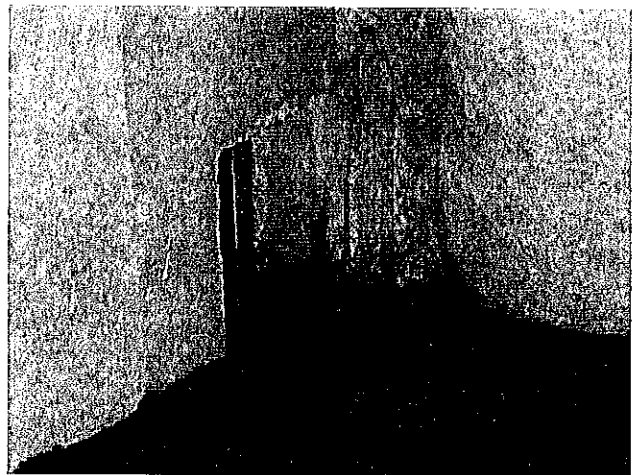
38. Close-up of pedestrian ramp scupper showing rust stains from reinforcement that is too close to the surface.

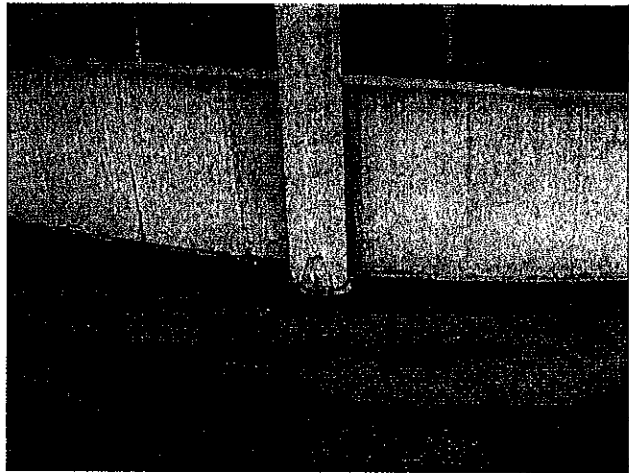
40. Corrosion of a pedestrian ramp column with less than adequate concrete cover over the reinforcing. Low concrete cover is common throughout the building.

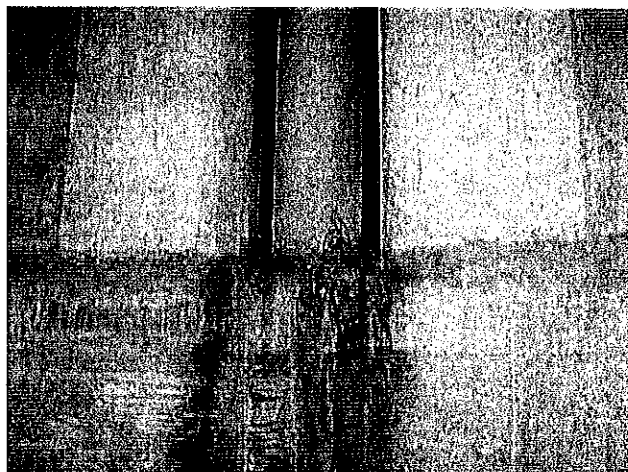
44. Corrosion of column base on top of retaining wall below Plaza Level on right field Pedestrian Ramp. Note stains from salts running along wall.

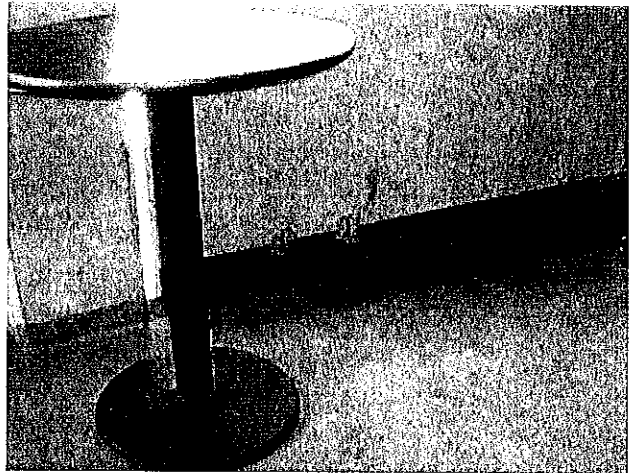
45. Corrosion popouts along Club Level wall near Section 234. Low concrete cover is the most typical cause for this type of distress.

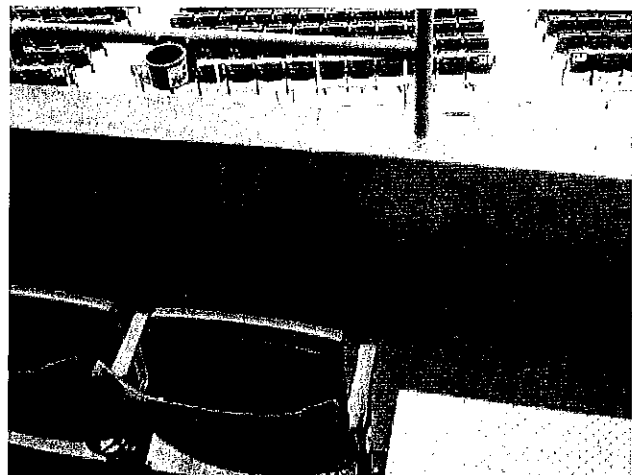
47. Corrosion popout from low concrete cover along a construction joint in right field Club Level Row A.

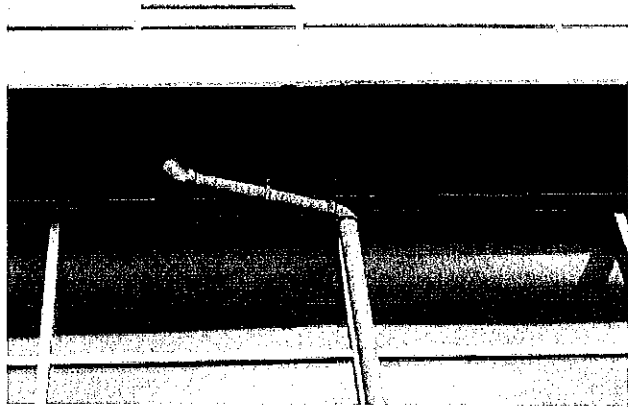
48. Corrosion of the 300 Level Row A slab soffit over the Stadium Club. Beam reinforcing was located against the forms when cast.

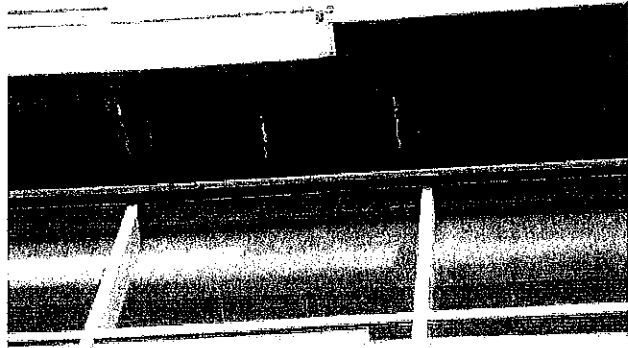
51. Cracks in the 300 Level Row A slab soffit with efflorescence. This condition indicates water movement through the cracks which can lead to corrosion and accelerate ASR distress.

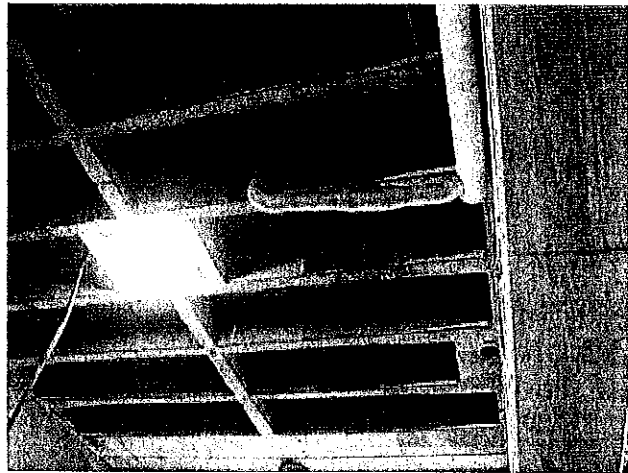
52. Leaking crack in Club Level slab along joist. Note reinforcing wire grid impression on the slab soffit, indicating minimal concrete cover over the wire.

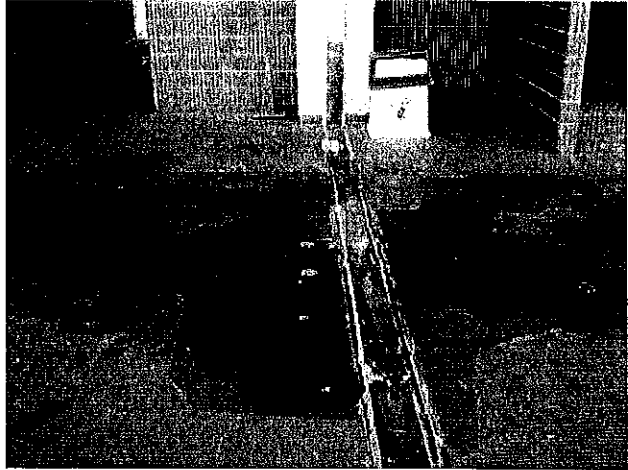
54. Damaged membrane coring locations at the View Concourse expansion joint near Section 323.

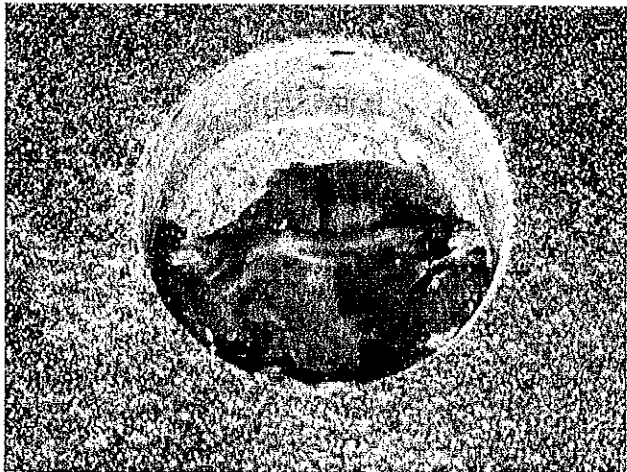
58. Core from damaged membrane area of View Concourse near Section 333 showing rubber membrane below topping slab over Stadium Club. The combination of an external coating with an intermediate waterproof layer traps moisture in the topping concrete that can accelerate coating failure.

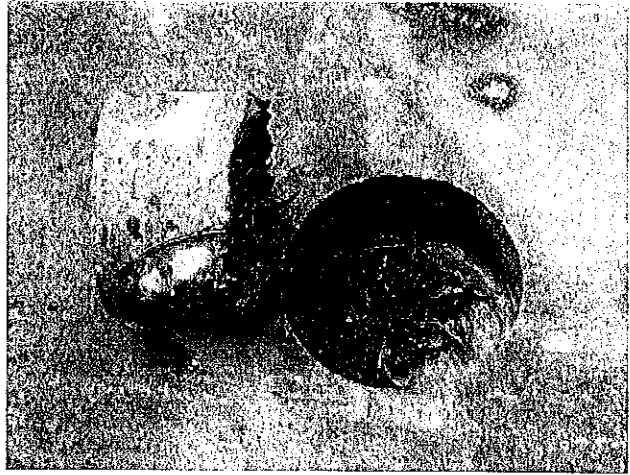
60. Core removed from the 333 portal damaged membrane area. Coring was halted when the intermediate membrane was encountered.

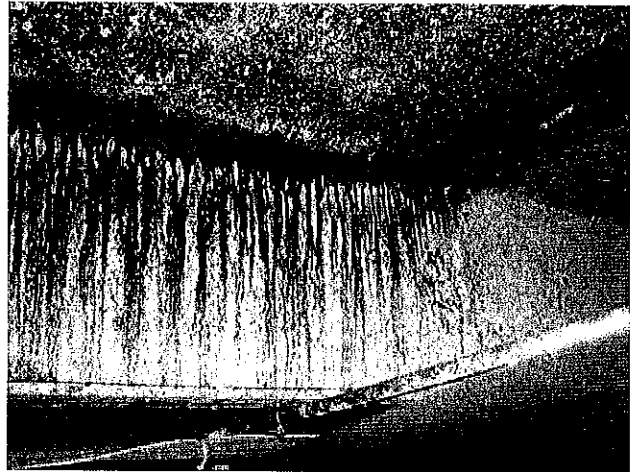
61. Ceiling of food storage room 014 with black staining below concession area. TCG attempted to remove a core from this ceiling for examination, but failed because the core snapped off at  $\frac{3}{4}$  inches at two locations. Coring was halted when the coring bit overheated. The concrete was not carbonated. Close examination indicates that the stain is a loose scale that is probably of organic origin. The scale can be removed by hand brush or pressure washing.

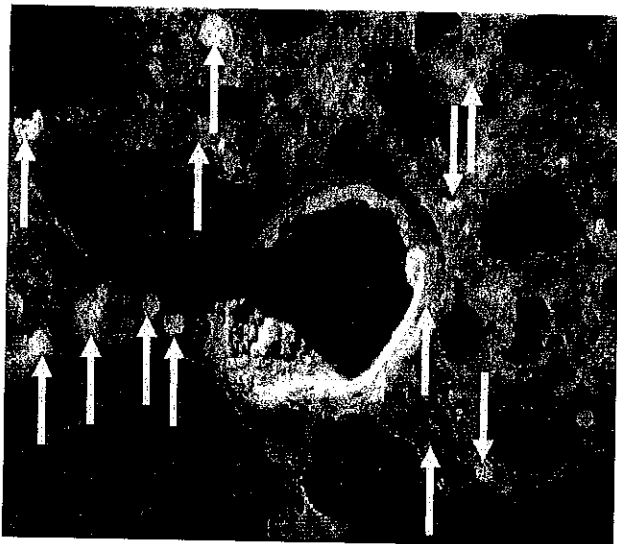
**PLATE 9**  
**ALKALIC GEL DEPOSIT IN LARGER VOID**  
**SOME VOID INFILLINGS SHOWN BY**  
**YELLOW ARROWS**

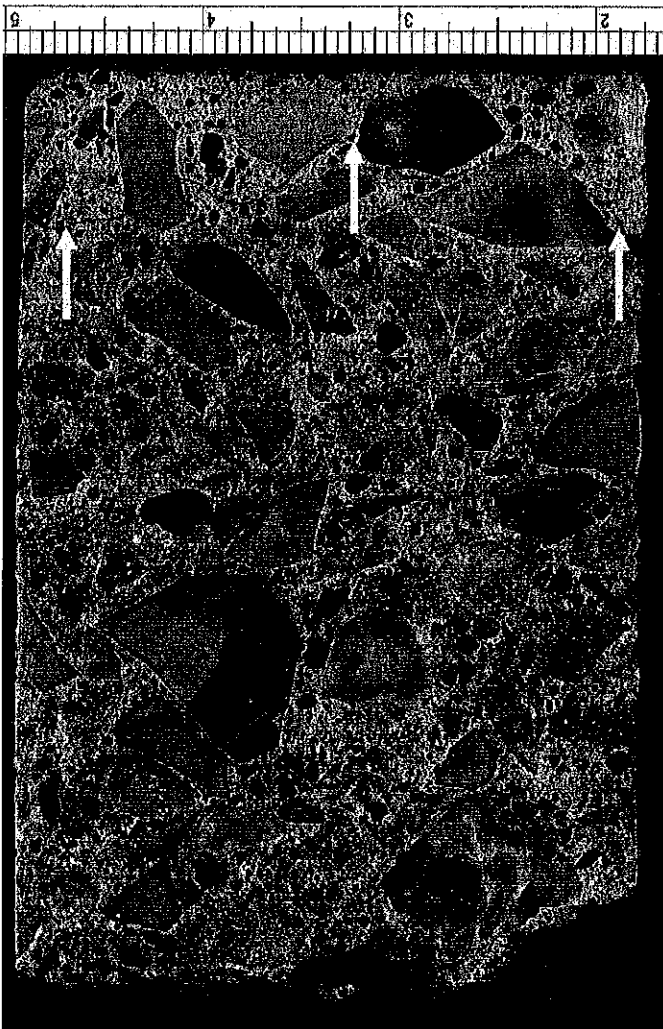
**GENERAL CONDITION:** (See PLATES 13 and 14) The top surface was generally flat and exhibited

**PLATE 14**  
**PREPARED SURFACE**  
**YELLOW ARROWS SHOWN PENCIL LINE THAT**  
**DENOTES LESS WATER ABSORPTIVE**  
**PORTION OF SAMPLE ADJACENT TO TOP**  
**SURFACE**

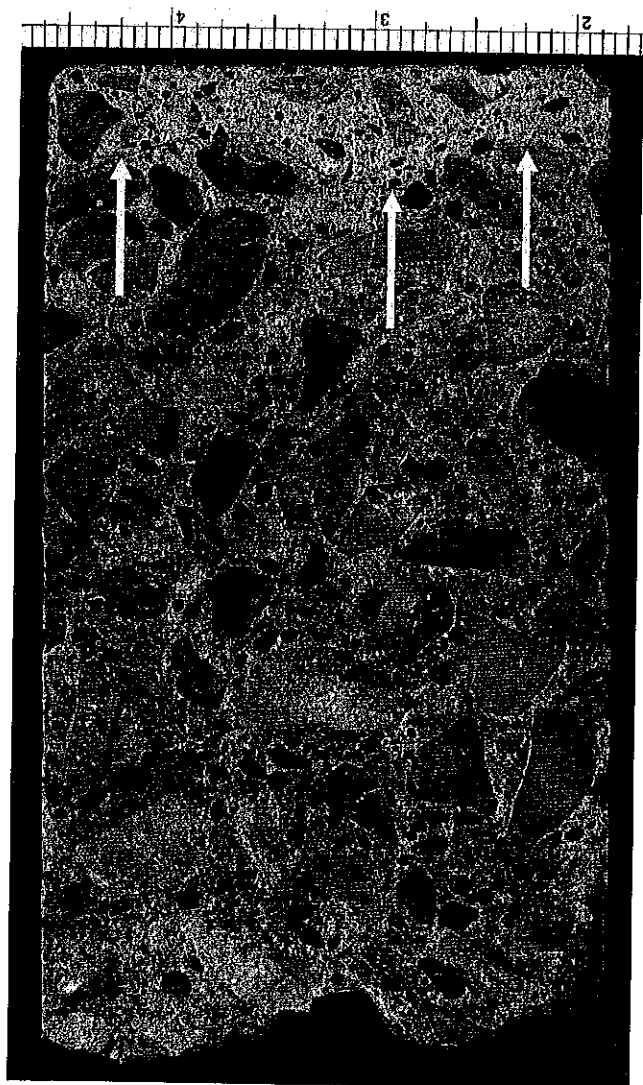
**GENERAL CONDITION:** (See PLATES 18 and 19) The top surface was generally flat and exhibited numerous partially exposed, fine aggregate particles in a recessed paste matrix. Loosely adhered, very fine,

**PLATE 19**  
**PREPARED SURFACE**  
**YELLOW ARROWS SHOWN PENCIL LINE THAT**  
**DENOTES LESS WATER ABSORPTIVE PORTION OF**  
**SAMPLE ADJACENT TO TOP SURFACE**

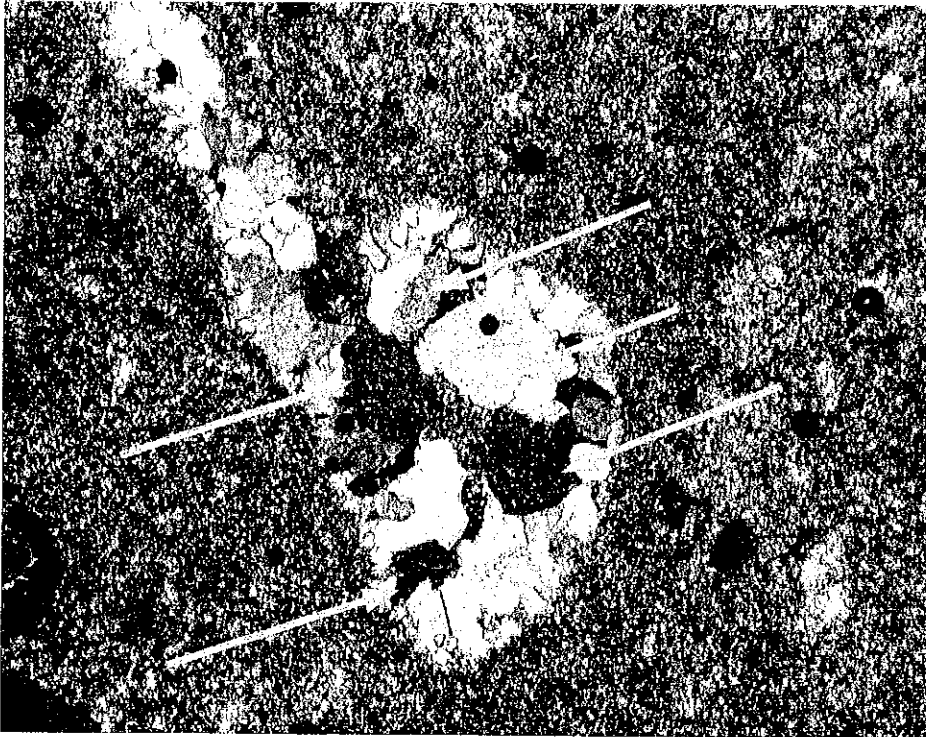
**PLATE 3**

**W.O.#: 07-08-31-01 ADDENDUM**  
**THIN SECTION VIEWS OF PORTIONS OF COARSE AGGREGATE PARTICLES**  
**UNDER CROSSED NICOLS**  
**YELLOW ARROWS SHOW MICROCRYSTALLINE SILICA**

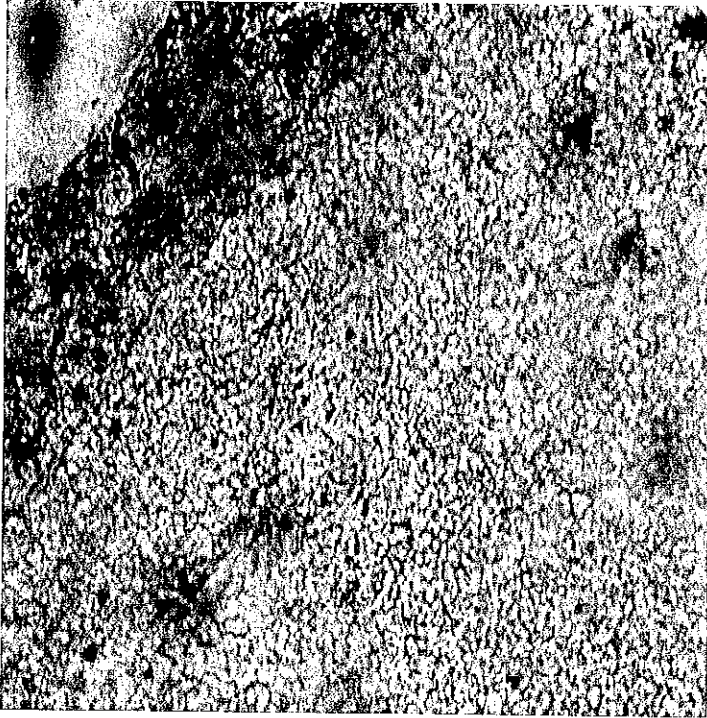
**PLATE 5  
THIN SECTION  
VIEW OF PORTION OF COARSE  
AGGREGATE PARTICLE  
UNDER PLANE POLARIZED LIGHT**

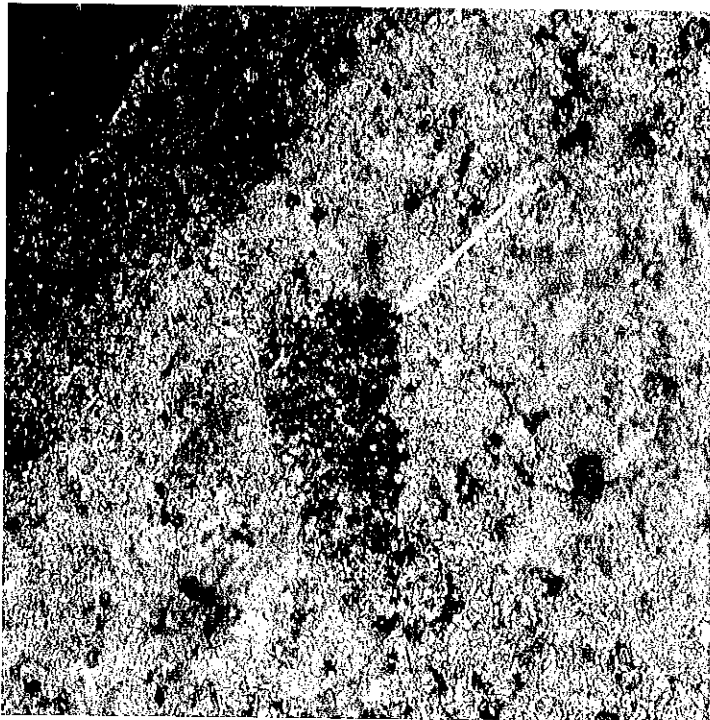
**PLATE 6  
THIN SECTION  
VIEW OF PLATE 5  
UNDER CROSSED NICOLS  
YELLOW ARROW SHOWS  
MICROCRYSTALLINE SILICA**

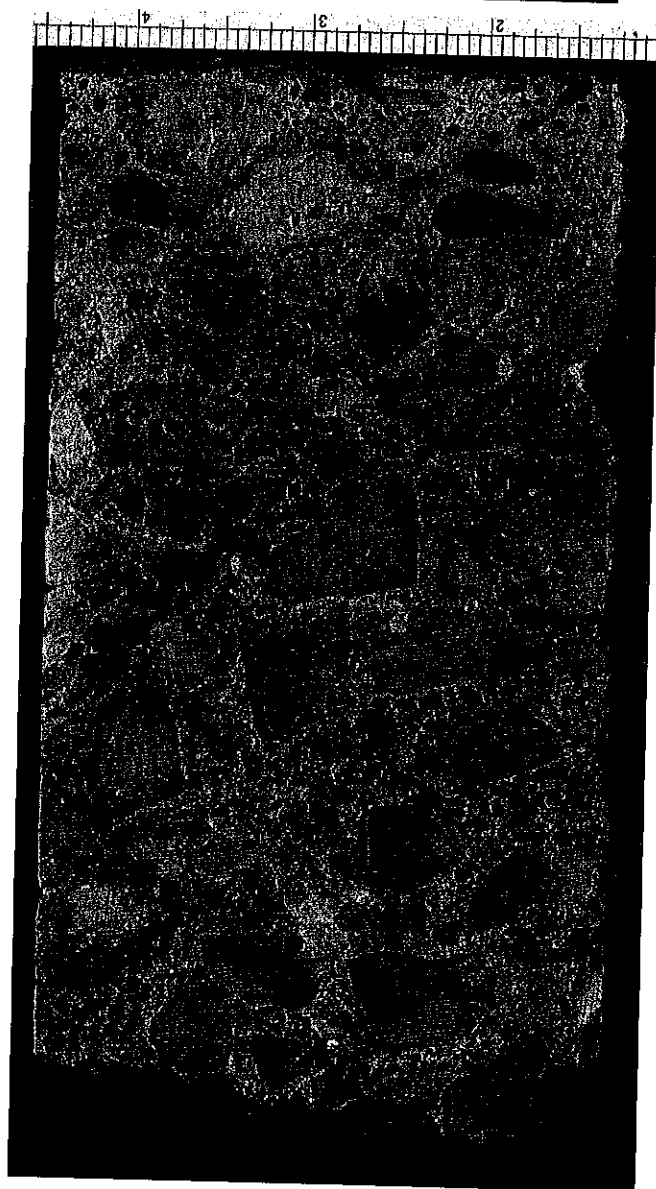
**PLATE 2**  
**PREPARED SURFACE**

**GENERAL CONDITION:** (See PLATES 1 and 2) The top surface was generally flat and exhibited a rough broomed finish with numerous partially exposed, fine aggregate particles in a slightly recessed paste matrix. Moderate amounts of small fragments of soft, rubbery black material were also present. Some of the black material could be easily washed from the surface. An approx. 1-inch diameter circular spot of yellow-colored material, presumed to be used for marking purposes, was also present at the exposed surface.

In section, a continuous zone of carbonated paste up to approx. 1/16 of an inch was observed. A small amount of microcracking was observed throughout the sample. Most of these microcracks were partially to completely infilled with white material with similar optical properties of alkalic gel and carbonated alkalic gel. The bottom surface was a fractured surface.

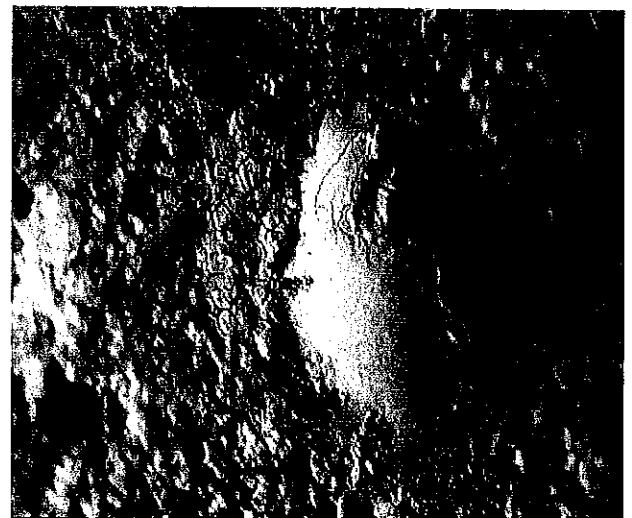
**PLATE 6**  
**CORE EDGE SURFACE SHOWING**  
**PARTIALLY CRACKED ALKALIC GEL**  
**EXUDATIONS**

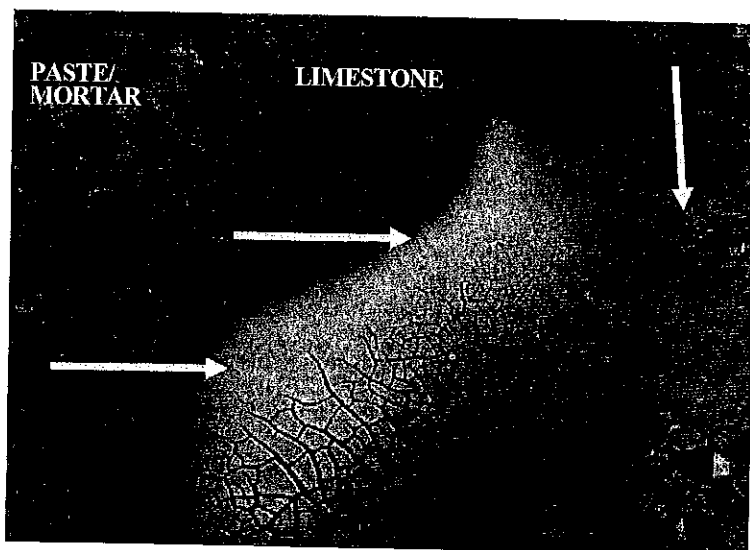
**PLATE 9**  
**CUT SURFACE SHOWING ALKALIC GEL**  
**EXUDATION (YELLOW ARROWS) ON**  
**LIMESTONE SURFACE AS A**  
**"SHEET-LIKE" DEPOSIT**

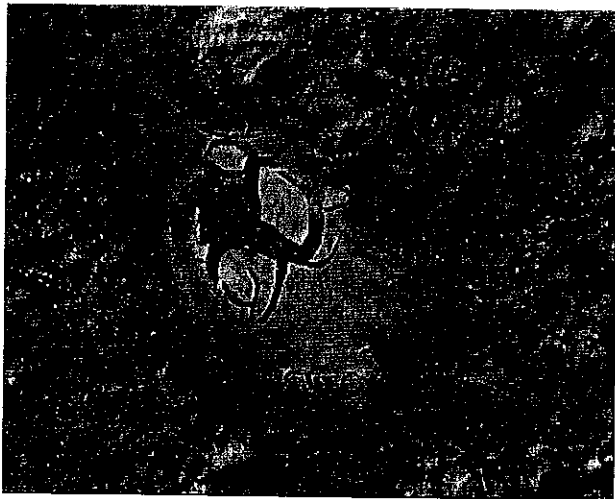
**PLATE 14**  
**CUT SURFACE SHOWING ALKALIC GEL**  
**EXUDATION OVER FINE AGGREGATE PARTICLE**

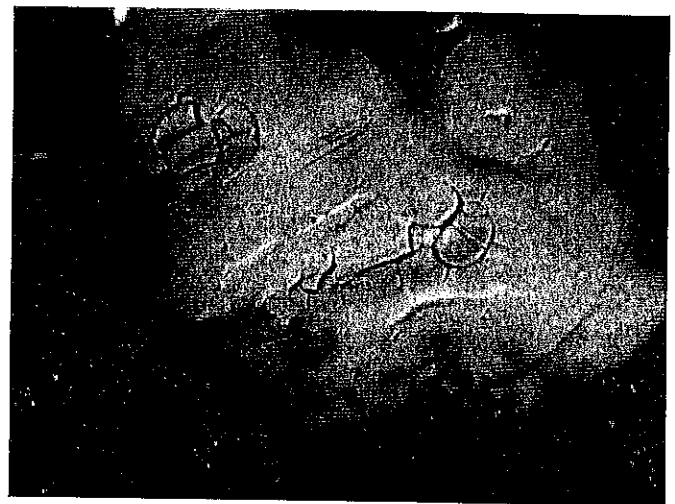
**PLATE 15**  
**CORE EDGE SURFACE SHOWING**  
**ALKALIC GEL EXUDATION**

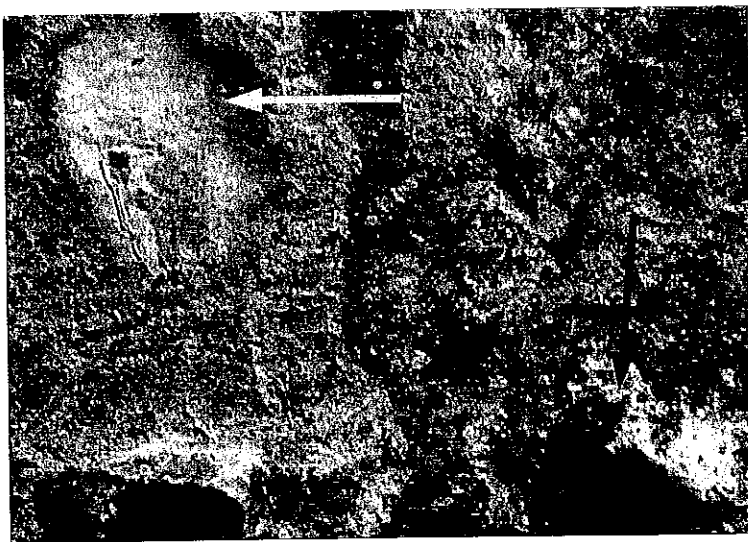
**PLATE 3  
CUT SURFACE  
YELLOW ARROW SHOWING ALKALIC GEL EXUDATION  
ON AGGREGATE SURFACE  
RED ARROW SHOWS CLEAR ALKALIC GEL EXUDATION  
IN ADJACENT VOID**

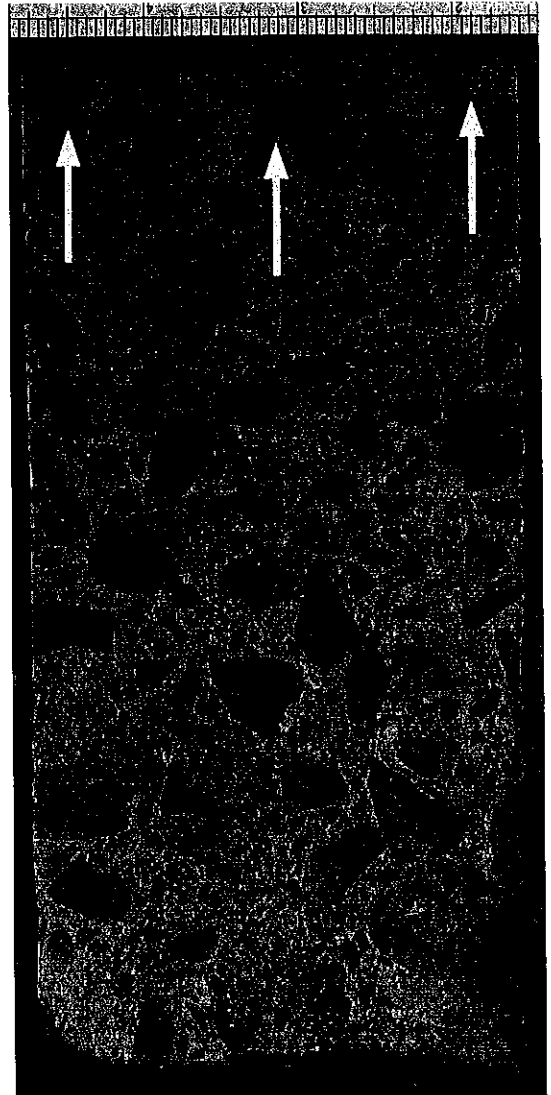
**PLATE 5  
PREPARED SURFACE  
YELLOW ARROWS SHOW PENCIL  
LINE DENOTING BOTTOM OF  
LESS WATER ABSORPTIVE ZONE  
ADJACENT TO TOP SURFACE**

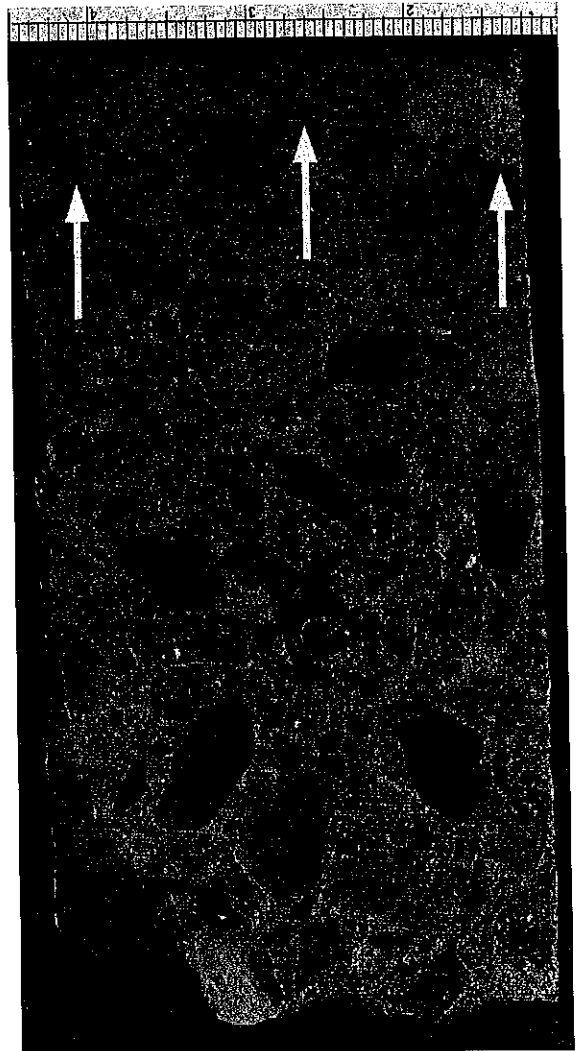
**PLATE 8  
PREPARED SURFACE  
YELLOW ARROWS SHOW PENCIL  
LINE DENOTING BOTTOM OF  
LESS WATER ABSORPTIVE ZONE  
ADJACENT TO TOP SURFACE**

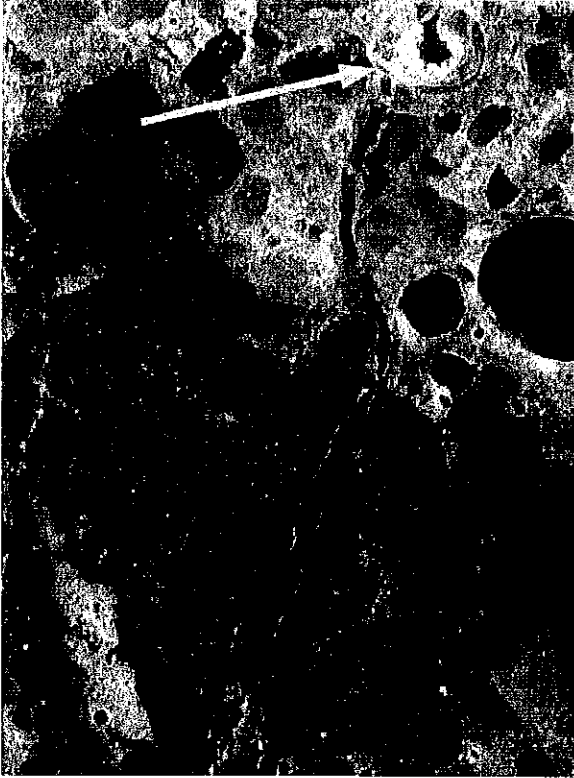
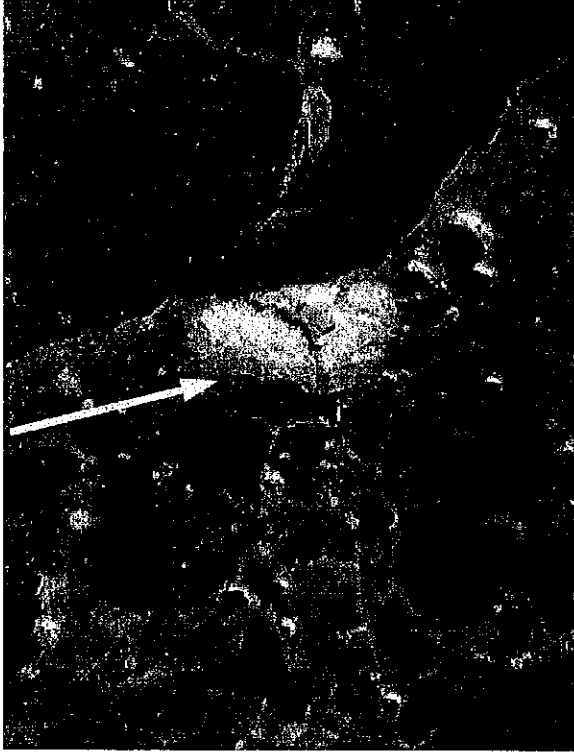
**PLATES 5 AND 6  
PREPARED SURFACE SHOWING CRACKING THROUGH AGGREGATE PARTICLES AND ADJACENT PASTE REGIONS  
CRACKED, CLEAR-OFF WHITE ALKALIC GEL EXUDATIONS IN VOIDS SHOWN BY YELLOW ARROWS**

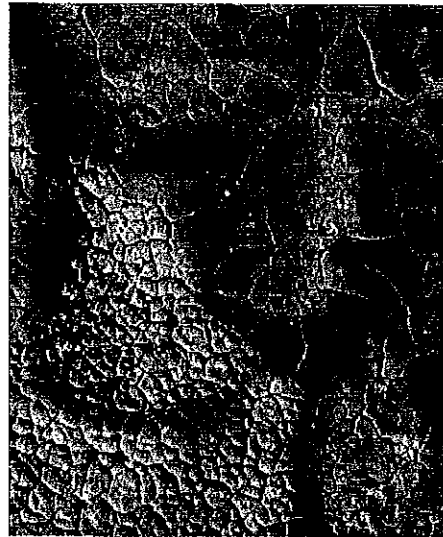
**PLATE 11  
TOP SURFACE SHOWING  
HEAVILY FRACTURED GRAY  
COATING MATERIAL**

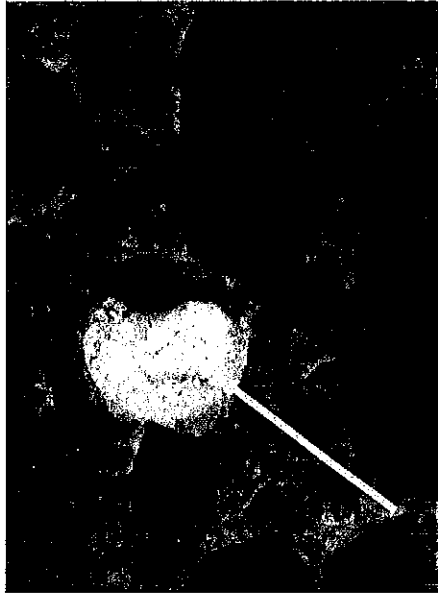
**PLATE 17  
PREPARED SURFACE SHOWING PARTIAL  
INFILLING OF CRACKED, WHITE ALKALIC  
GEL IN VOID (YELLOW ARROW)**
