Concrete Materials Testing of  
**Kauffman Stadium**  
Kansas City, MO

Prepared For:  
Kansas City Royals Baseball Corporation and  
Jackson County Sports Complex Authority and  
One Royals Way  
Kansas City, MO 64129

December 19, 2007

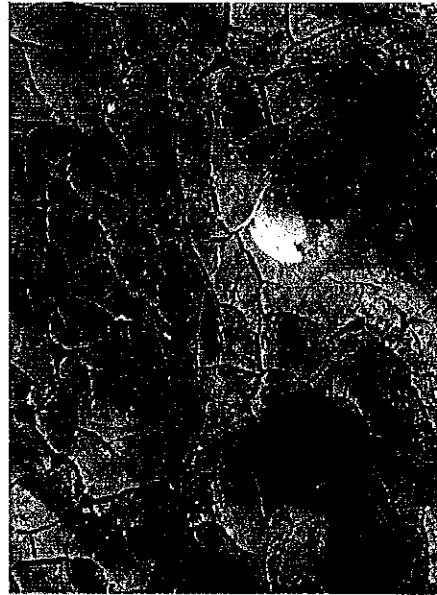
**PLATE 15  
TOP SURFACE SHOWING HEAVILY  
FRACTURED GRAY COATING  
MATERIAL**

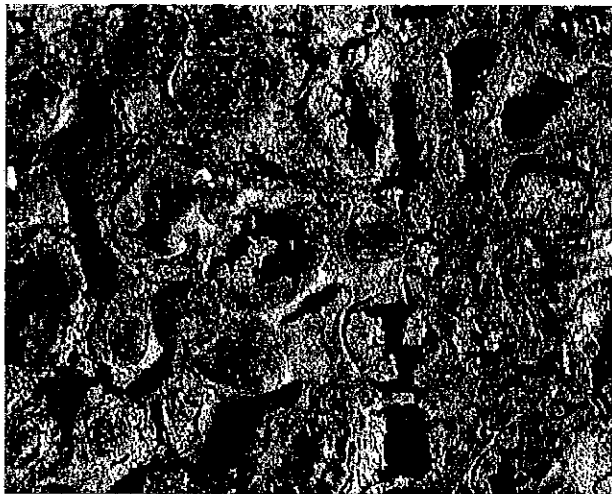
**PLATE 5**  
**TOP SURFACE SHOWING HEAVILY**  
**CRACKED GRAY COATING MATERIAL**  
**AND EXPOSED FINE AGGREGATE**  
**PARTICLES**

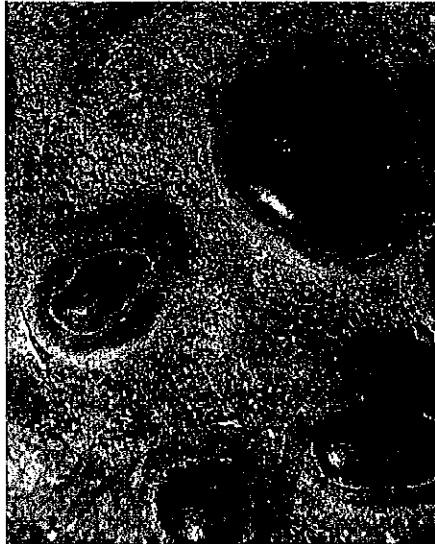
**PLATE 7  
TOP SURFACE SHOWING BOTH  
"SMOOTH" AND FINELY  
CRACKED PORTIONS OF GRAY  
COATING MATERIAL WITH  
EXPOSED FINE AGGREGATE  
PARTICLES**

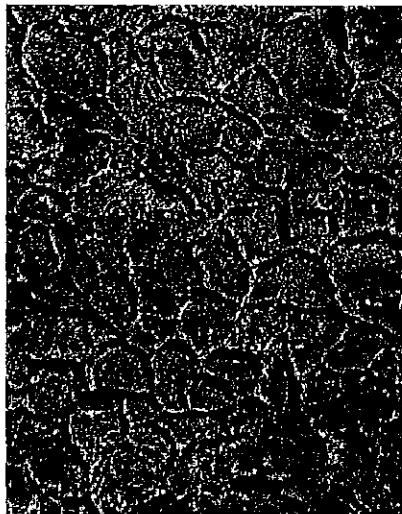
**PLATE 12  
TOP SURFACE SHOWING  
HEAVILY CRACKED GRAY  
COATING MATERIAL AND A  
FEW EXPOSED FINE  
AGGREGATE PARTICLES**

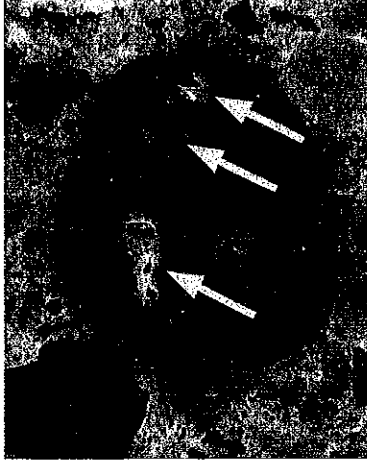
**PLATE 19  
PREPARED SURFACE  
"209 P2" SHOWING  
ALKALIC GEL  
EXUDATIONS ON A  
CHERT PARTICLE**

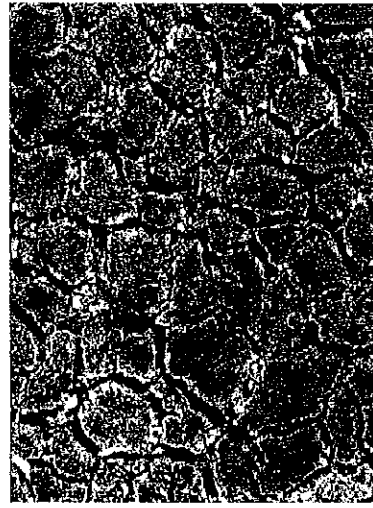
**PLATE 17  
TOP SURFACE SHOWING LOCALIZED  
FINE, "MUD-CRACK"-TYPE  
CRACKING IN THE GRAY COATING  
MATERIAL**

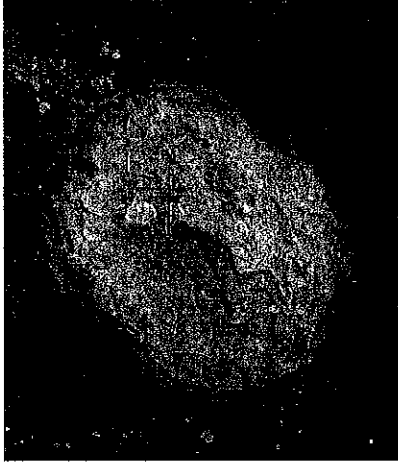
**PLATE 24  
PREPARED SURFACE  
SHOWING OFF-WHITE,  
CRACKED ALALKIC  
GEL INFILLING VOID**

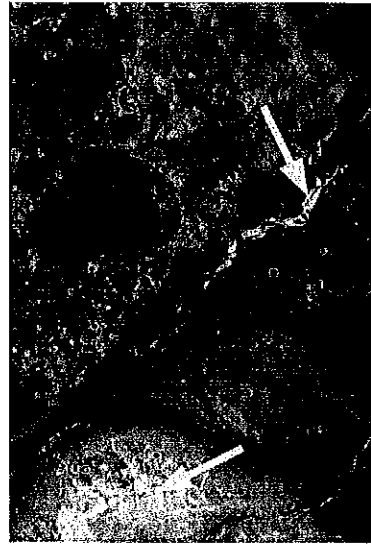
**PLATE 22  
PREPARED SURFACE SHOWING  
ALKALIC GEL EXUDATIONS WITHIN  
AGGREGATE PARTICLE AND IN  
SURROUNDING PASTE**

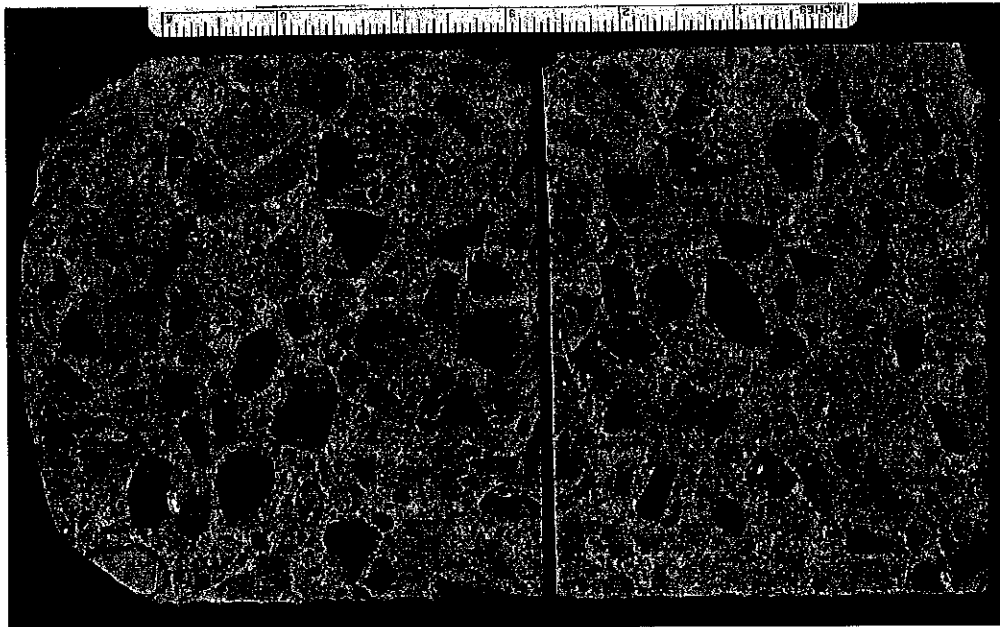
**PLATE 1**  
**PREPARED SURFACE SECTIONS**

**GENERAL CONDITION:** (See PLATES 1-4) The top surface exhibited numerous, circular scratches/gouges that are presumed to be from the coring procedure. The edges at the top surface were "beveled" outward from the top surface toward the core edge, that is at an obtuse angle.

In section, no carbonation was observed. A small amount of microcracking and cracking was observed

throughout the sample. Most of the cracks appeared to be “fresh” and jagged and were free of any secondary deposits. The bottom surface was a fractured surface.

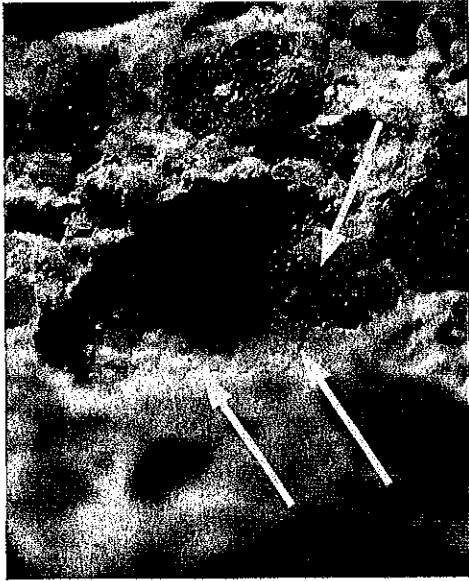
**PLATE 2**  
**FRACTURED SURFACE SHOWING**  
**CLEAR TO OFF-WHITE, CRACKED GEL**  
**LINING IN VOID**

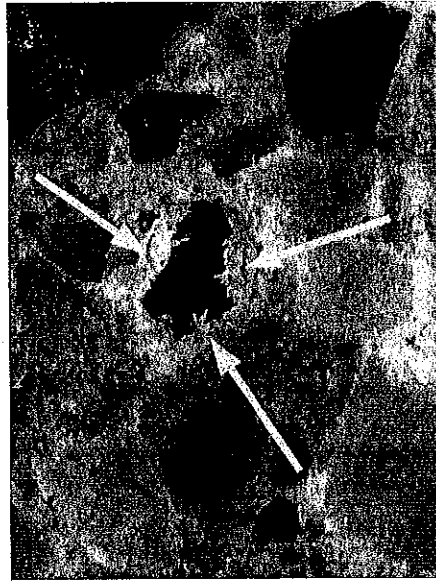
**PLATE 3**  
**PREPARED SURFACE SHOWING**  
**TUFTS/PARTIAL LININGS OF ETTRINGITE**  
**CRYSTALS**

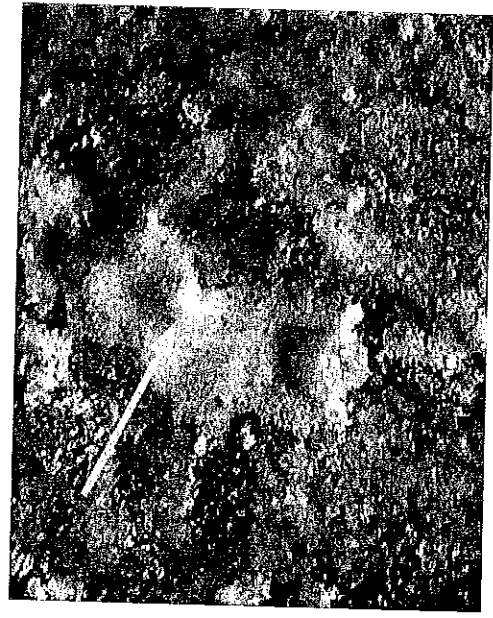
**PLATE 2  
CUT SURFACE "103TD-P" SHOWING  
OFF-WHITE, GEL EXUDATION**

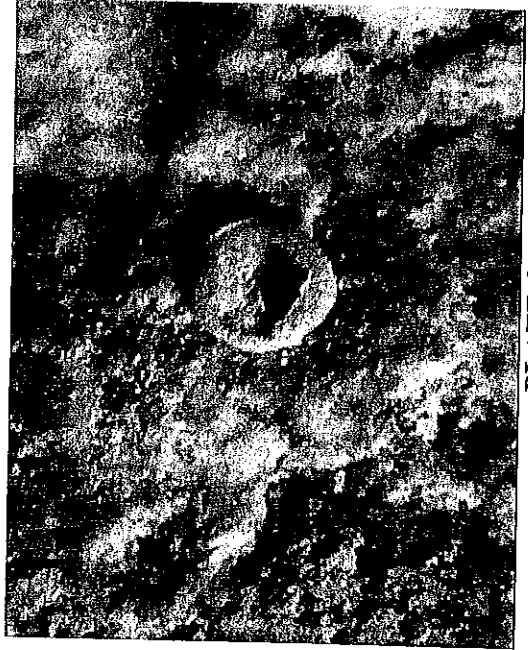
PLATE 6  
CUT SURFACE "103TUD-P" SHOWING  
CRACKED GEL "BUBBLE" EXUDATION

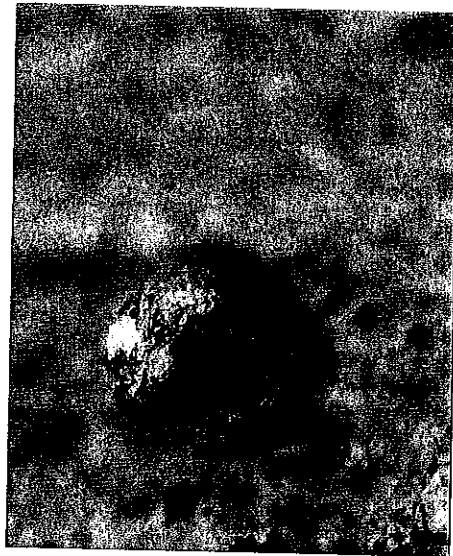
**PLATE 10  
CUT SURFACE "SLA16-P" SHOWING  
OFF-WHITE INTRINSALLY  
RADIATING CRYSTALS OF  
ETTRINGITE IN VOID**

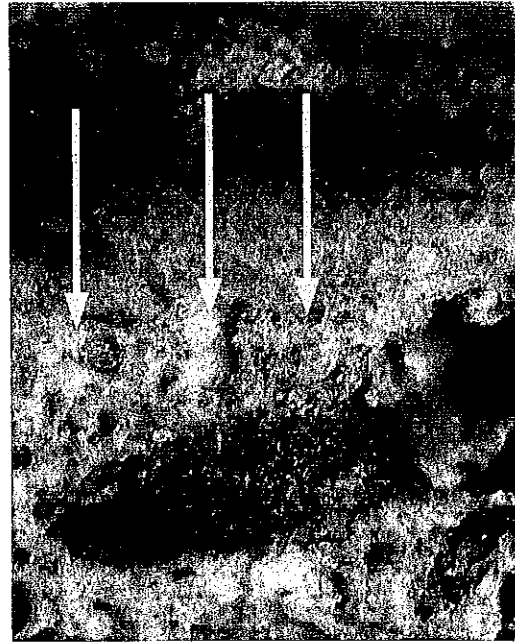
**PLATE 14  
CUT SURFACE SHOWING CLEAR TO OFF-  
WHITE GEL EXUDATIONS ON PASTE**

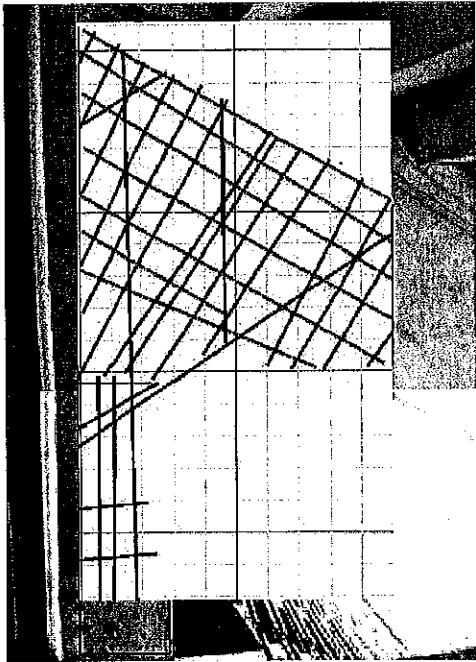
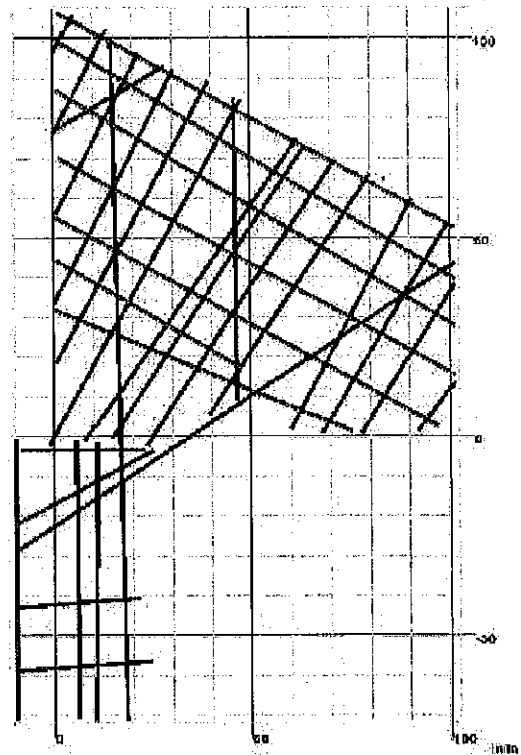
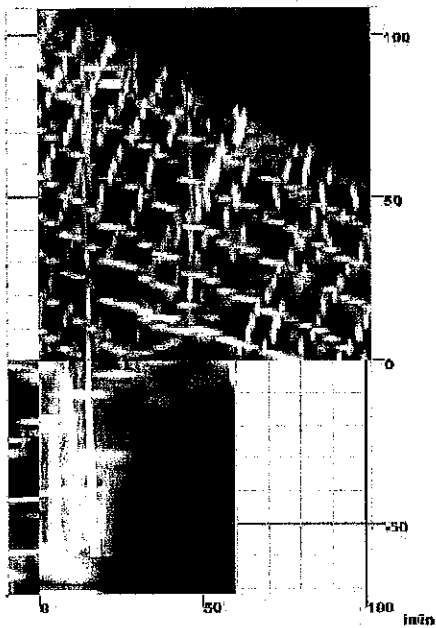
### 4.1.1 Scan Results

Deterioration was present on the bottom edge of the spandrel panel near Section 139. Reinforcement details were requested to facilitate the repair. An attempt was made to provide clues as to how the connection is made between the column and the spandrel panel.
